Manhole Inspection Summary

Manhole # S03WW1024MH

Insp Date: **8/16/06 12:00 AM**

Location Address: **3317 Devonshire Dr**

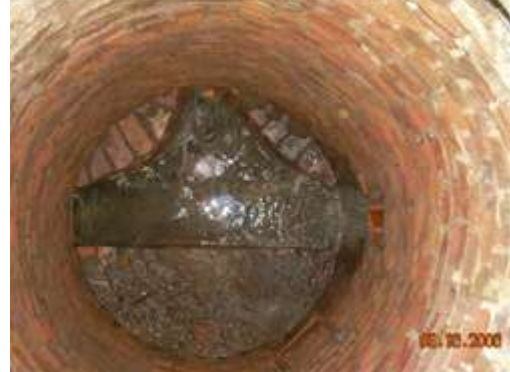
Top View

Adjustment, Corbel, and Barrel infiltration.
Corroded steps. Bench debris. Channel
debris.

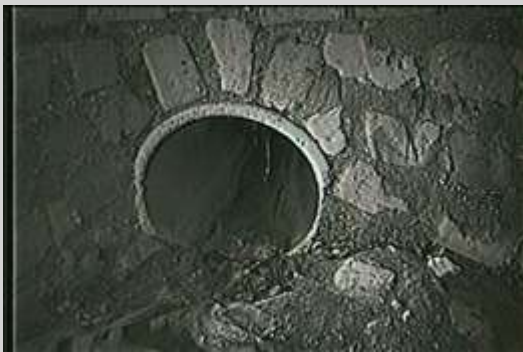
8 in. Circular Gravity Sewer Pipe Out @ 12 O'Clock

Infiltration: **Evidence** Pipe Seal Cond: **Unknown**

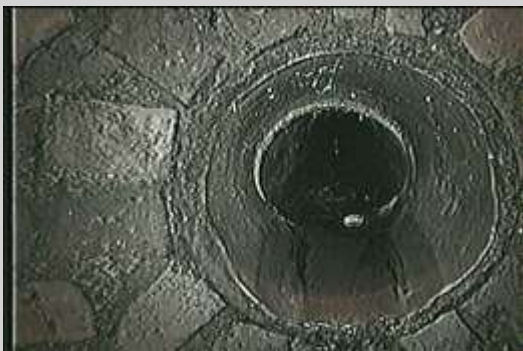
8 in. Circular Gravity Sewer Pipe In @ 3 O'Clock

Infiltration: **Evidence** Pipe Seal Cond: **Unknown**

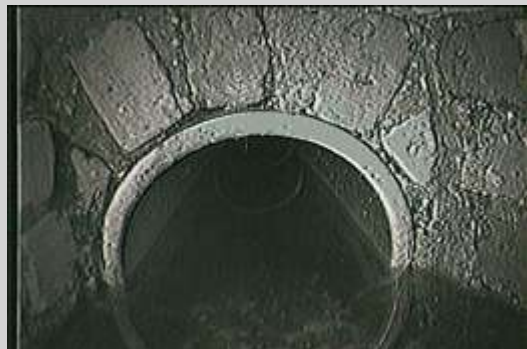
8 in. Circular Gravity Sewer

Infiltration: **Evidence**
